United Nations / SARC Aid Convoy  
Damage Assessment  
Urum al Kubrah  
Aleppo Governorate, Syria

UNITAR-UNOSAT conducted a satellite imagery based damage assessment on the road between Urum an Kubrah and Kafr Naha in Aleppo Governorate in the vicinity of 36°9'3.36"N 36°58'2.12"E in an effort to identify the location where the Syrian Arab Red Crescent / UN aid convoy suffered an alleged attack on the evening of 19 September. Using imagery acquired on 21 September 2016 and comparing it with imagery collected on 18 September 2016 and 5 August 2016, UNOSAT identified one area in the road between the two aforementioned cities where at least 16 transportation trucks and one small SUV are visibly damaged and scorched as of 21 September.

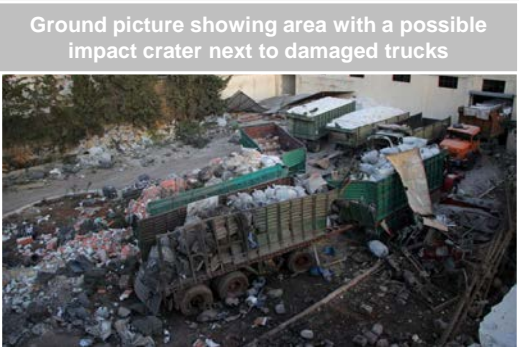
### Damage Assessment UN – SARC Warehouse Entrance

Ground picture showing area outside the SARC warehouse where seven transportation trucks were parked at the moment of the attack. Please note that location of trucks in the ground picture and satellite image match, except for truck number 1 in the satellite image, which cannot be seen due to the view angle of the photo.

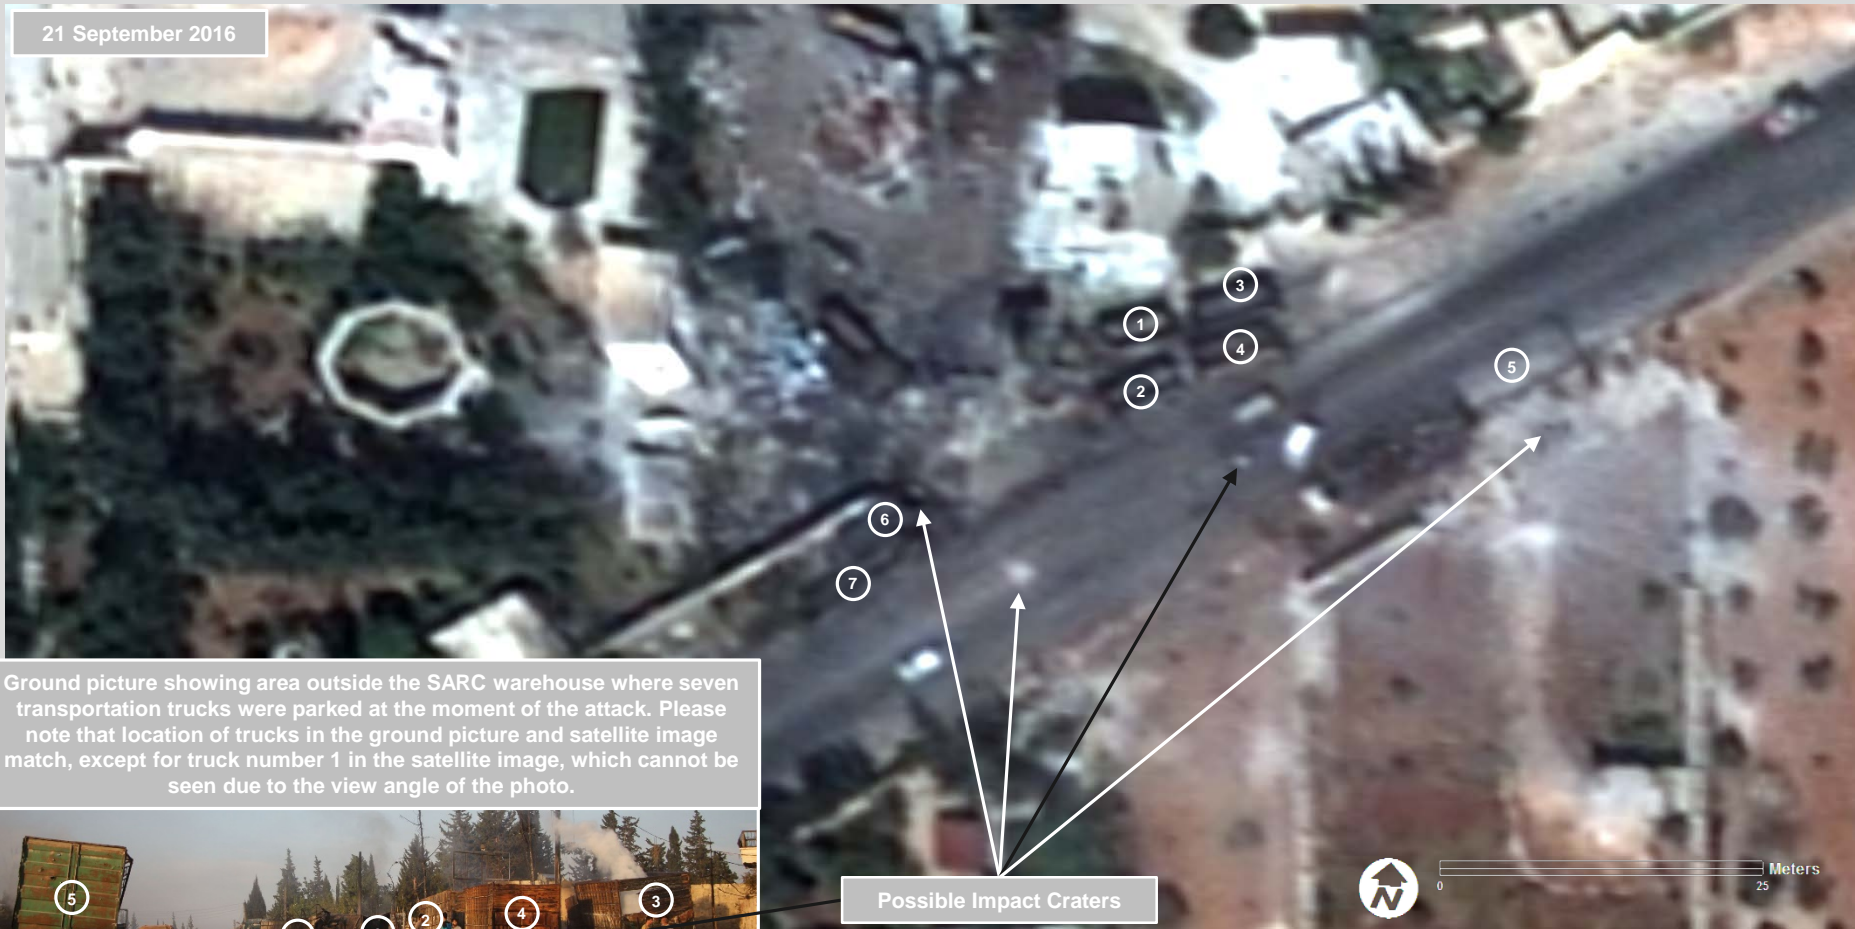
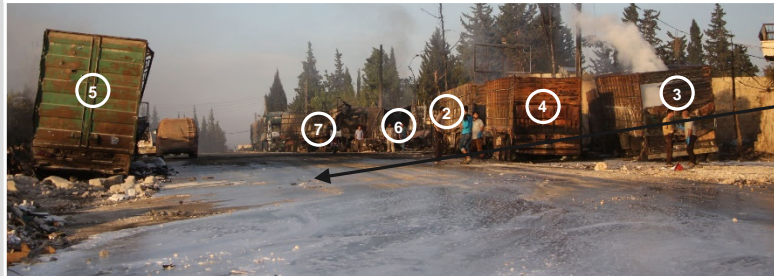
Possible Impact Craters

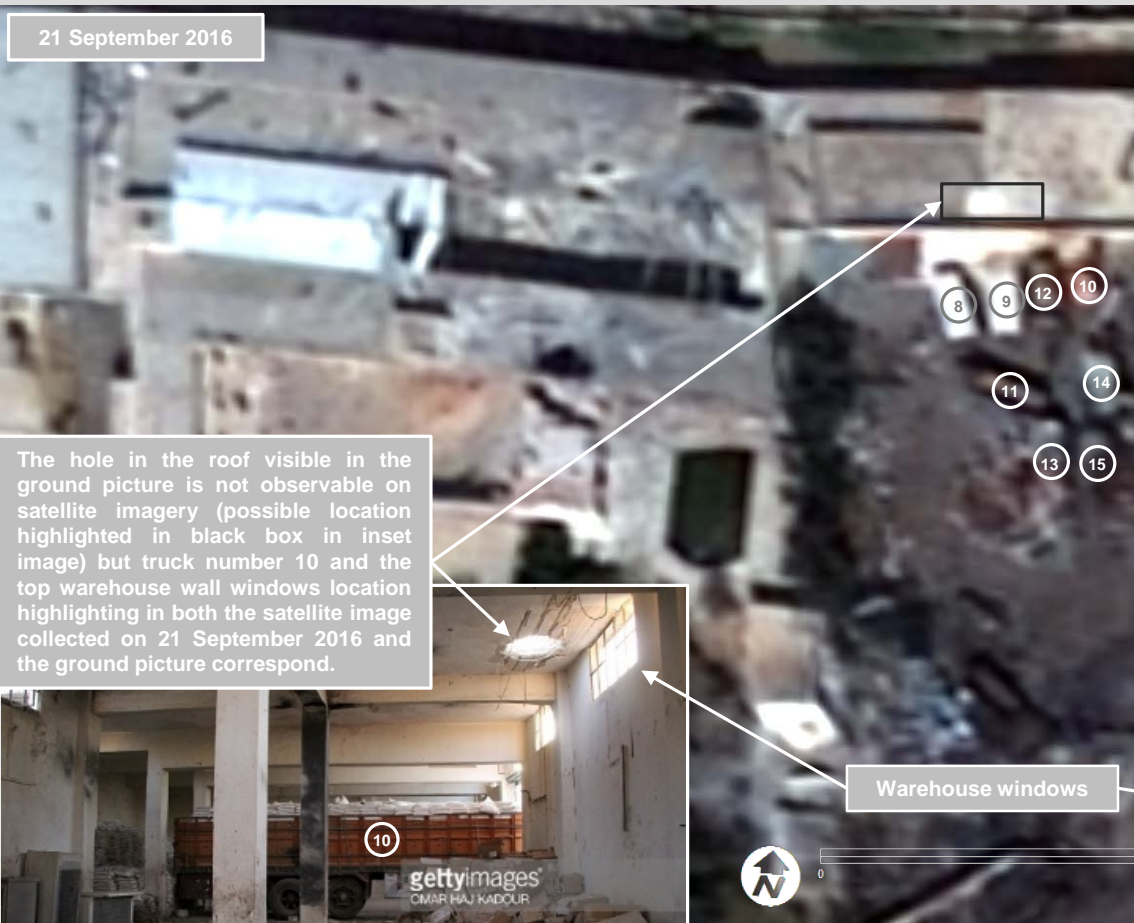
## Damage Assessment

Ground picture showing area inside the SARC warehouse where transportation trucks were parked at the moment of the alleged attack. Please note that location of trucks in the ground picture and satellite image match.

The hole in the roof visible in the ground picture is not observable on satellite imagery (possible location highlighted in black box in inset image) but truck number 10 and the top warehouse wall windows location highlighting in both the satellite image collected on 21 September 2016 and the ground picture correspond.
