# Satellite image analysis in support to the United Nations Fact Finding Mission on the Gaza Conflict

A report to the UN Office of the High Commissioner for Human Rights (UN OHCHR)

31 July 2009

Prepared by UNITAR Operational Satellite Applications Programme (UNOSAT)

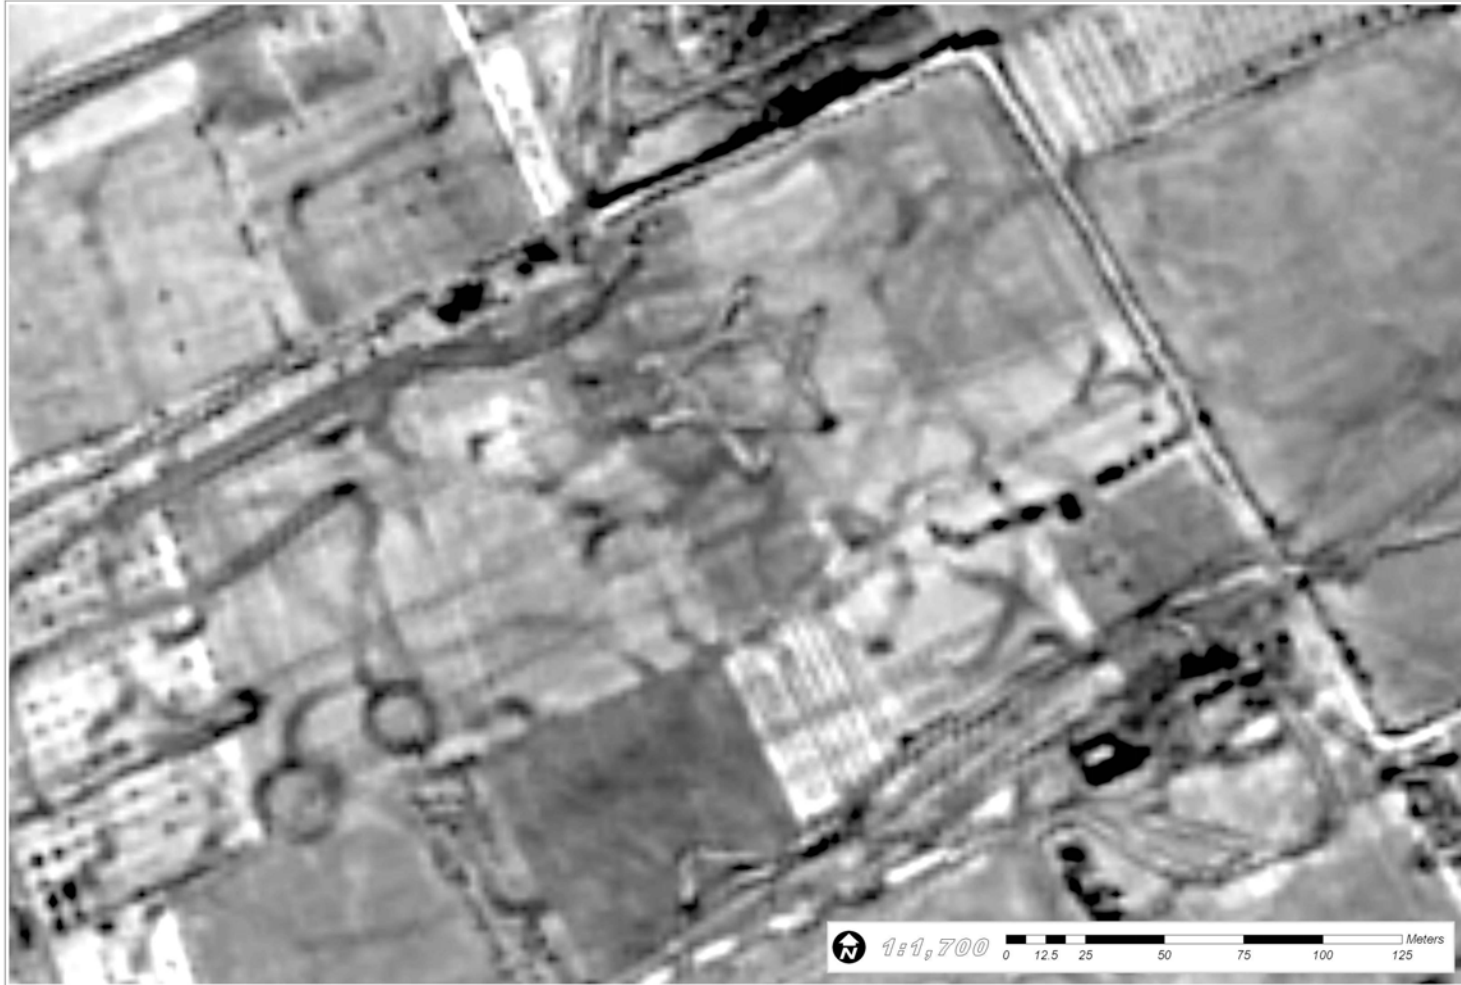
As shown in figure 3, not only do the ground signatures include tank tracks across cultivated fields and paved roads, but also a Star of David measuring 60m in diameter carved into the soil likely by IDF vehicles. It is important to note that this pattern was created during the first week of the IDF ground incursion into Gaza, sometime between 3-10 January 2009. Based on this analysis, it is probable that building damage within this area of Rafah Governorate were likely caused by a combination of IAF air strikes and IDF ground fire.

Figure 3: Star of David and other patterns carved into the soil

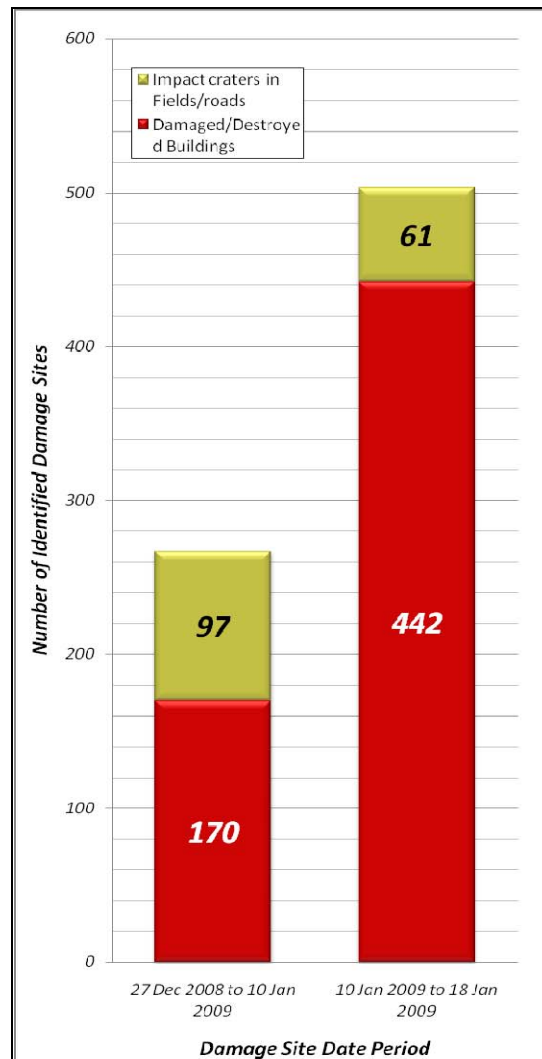
As illustrated in table 1 and graph 1, during the first period from 27 December 2008 to 10 January 2009, a total of 267 damage sites were identified, representing 34% of the total damage sites identified within 2km of border by the end of the conflict. Of these damages, 170 buildings were targeted during this time, representing 62.9% of all damage sites, with the remaining sites located on roads or fields. During the second period between 11 -18 January 2009, the number of newly detected damage sites increased to 503, 87.8% (442) of which were building targets. By way of comparison, the daily average of new damage sites for the first period was 17.9, in contrast with the daily average of 62.9 new damage sites for the second period 11 -18 January 2009<sup>1</sup>.

Graph1: Number of identified damage sites by date period for Rafah border with Egypt

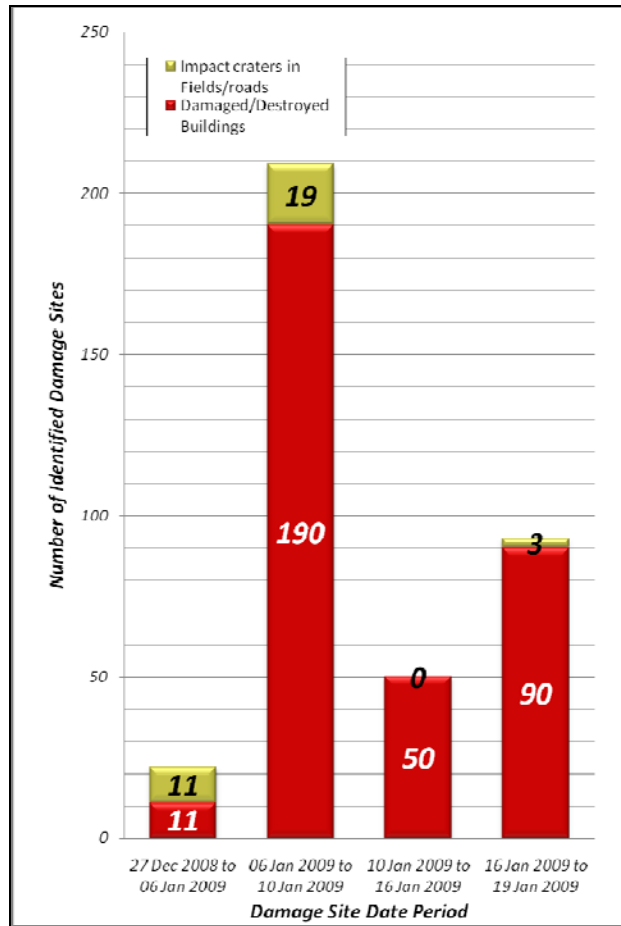
Further, it was estimated that approximately 12.3km of roads had been severely damaged from a combination of intense IAF shelling and IDF tank movement on the ground. As the time series in table 4 and graph 2 illustrate below, the majority of building destruction occurred between 6 and 10 January 2009, when an estimated 190 buildings were either destroyed or severely damaged, representing 55.7% of all affected buildings in the area during the conflict.

Graph 2: Graphical representation of number of identified damage sites within Izbet Abed Rabbo area sorted by date and type

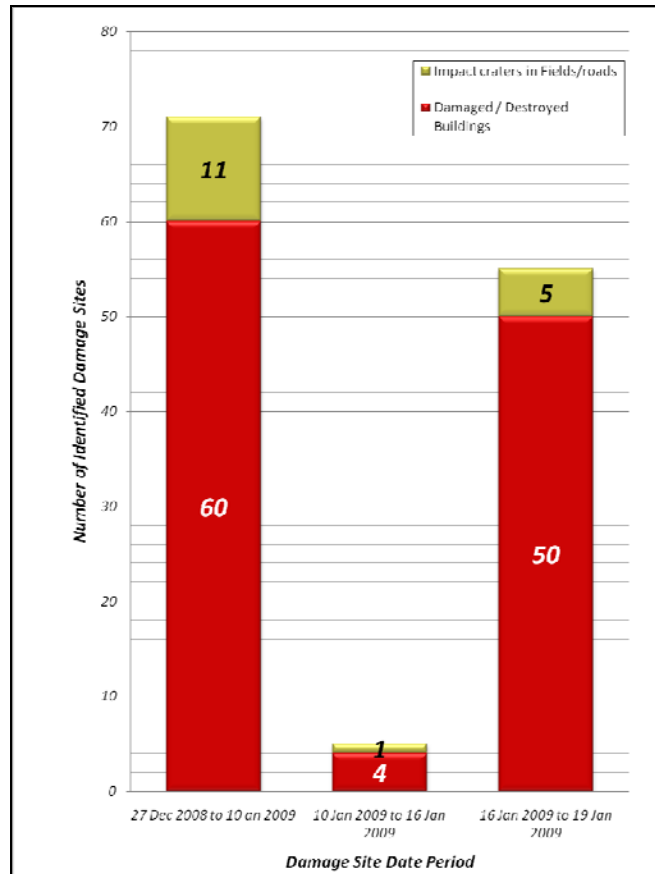
Further, it was estimated that approximately 7.5km of roads had been severely damaged from a combination of intense IAF shelling and IDF tank movement on the ground. As the time series in table 5 and graph 3 illustrate below, the majority of building destruction occurred between 27 December 2008 and 10 January 2009, when an estimated 60 buildings were either destroyed or severely damaged, representing 52.6% of all affected buildings in the area during the conflict.

Graph 3: Graphical representation of number of identified damage sites within Samouni Street area sorted by date and type

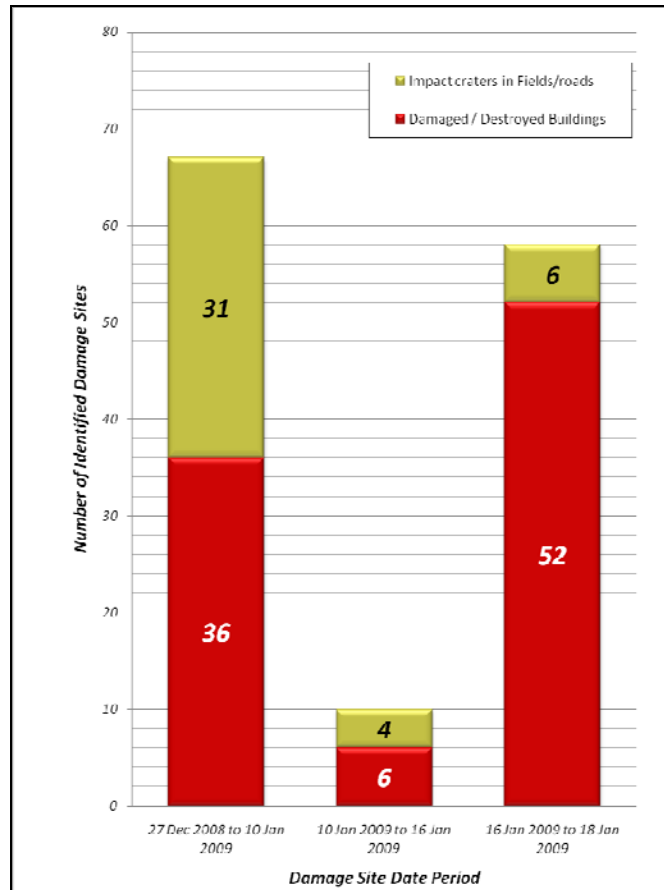
Further, it was estimated that approximately 4.8km of roads had been severely damaged or destroyed from a combination of intense IAF shelling and IDF tank movement on the ground. As the time series in table 6 and graph 4 illustrate below, the majority of detected damage sites (91) were identified between 27 December 2008 and 10 January 2009. These sites included the destruction of the American International School, as well as multiple impact craters situated within densely populated areas of the neighborhood measuring up to 20 meters in diameter.

There appears to have been a reduction in the newly identified damage sites between 10 and 16 January with only 22 detected. This increased apparently in the last few days of the conflict, between 16 and 18 January 2009, when an estimated 52 buildings were either destroyed or severely damaged, representing 55.3% of all affected buildings in the area during the conflict.

Graph 4: Graphical representation of number of identified damage sites within Al Atatra area sorted by date and type

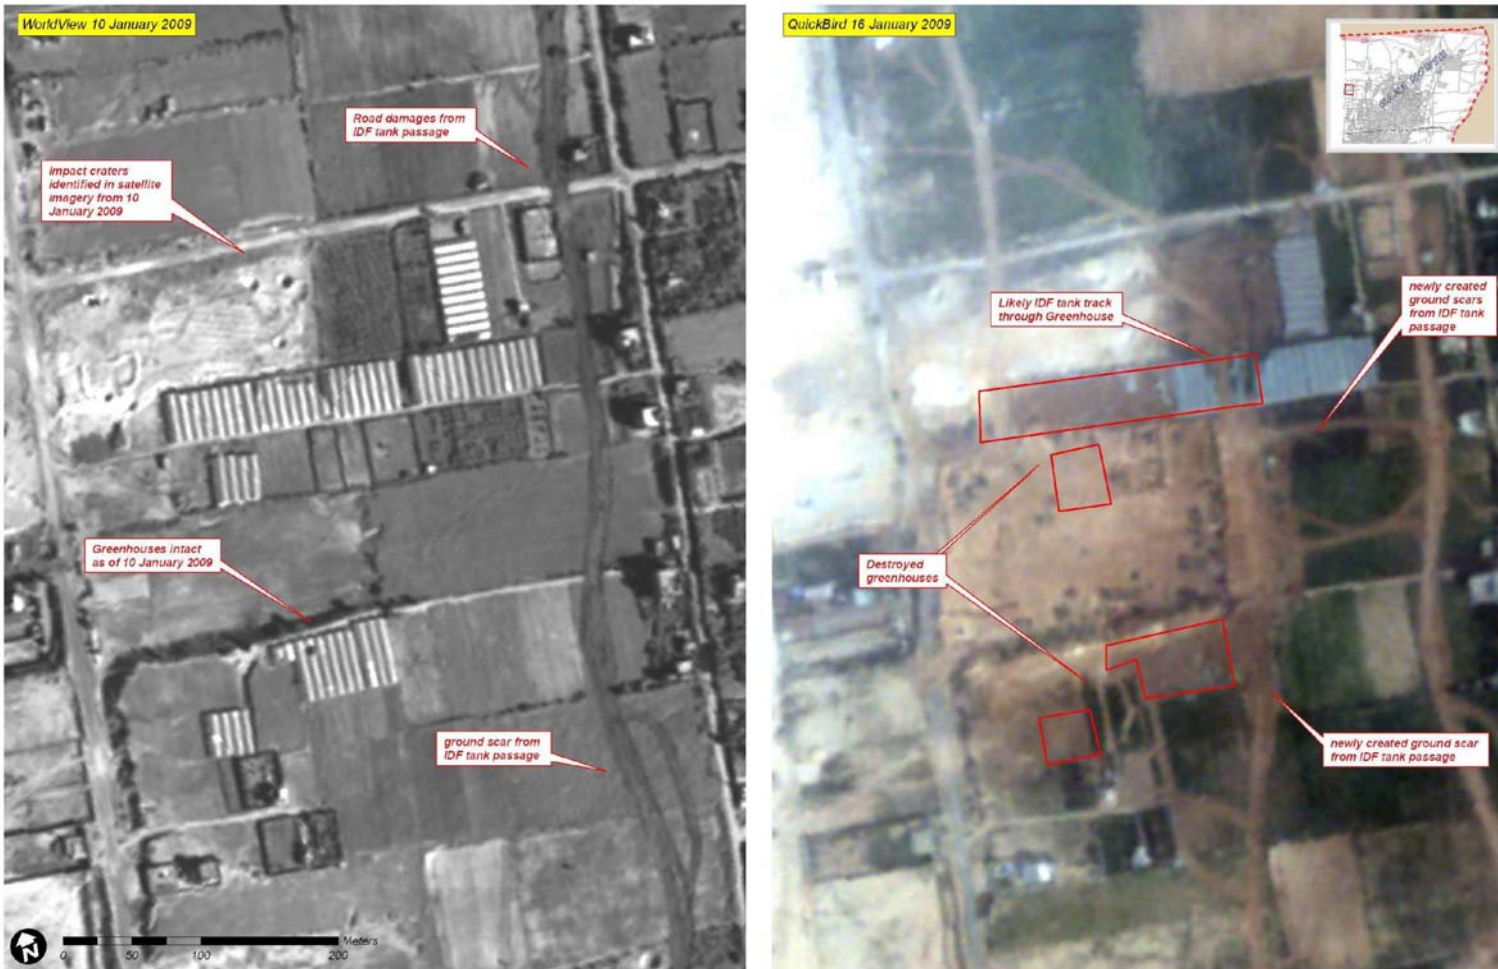
**SITE EXAMPLE OF PROBABLE GREENHOUSE DESTRUCTION BY IDF GROUND ACTIVITY IN NORTH GAZA**

With respect to the probable cause of greenhouse damage in Khuza'a village, and more generally across Gaza, there are strong indications in the satellite imagery that IDF tank and/or heavy vehicles were likely responsible for a major proportion of all greenhouse damage identified in this analysis. The presence on the ground of what is likely multiple tank tracks across cultivated fields and paved roads is strong evidence of IDF ground activity, and in at least one case on the western edge of the Atatra neighborhood, North Gaza, there is a probable tank track running through the center of a destroyed greenhouse complex (see figure 11).

Figure 11: Site example of probable greenhouse destruction by IDF ground activity
